**SYSTEM DIAGNOSTICS:
A CASE STUDY FROM THE CITY OF VAUGHAN**

Fabian Papa, Fabian Papa & Partners Inc.*

Michael Frieri, City of Vaughan

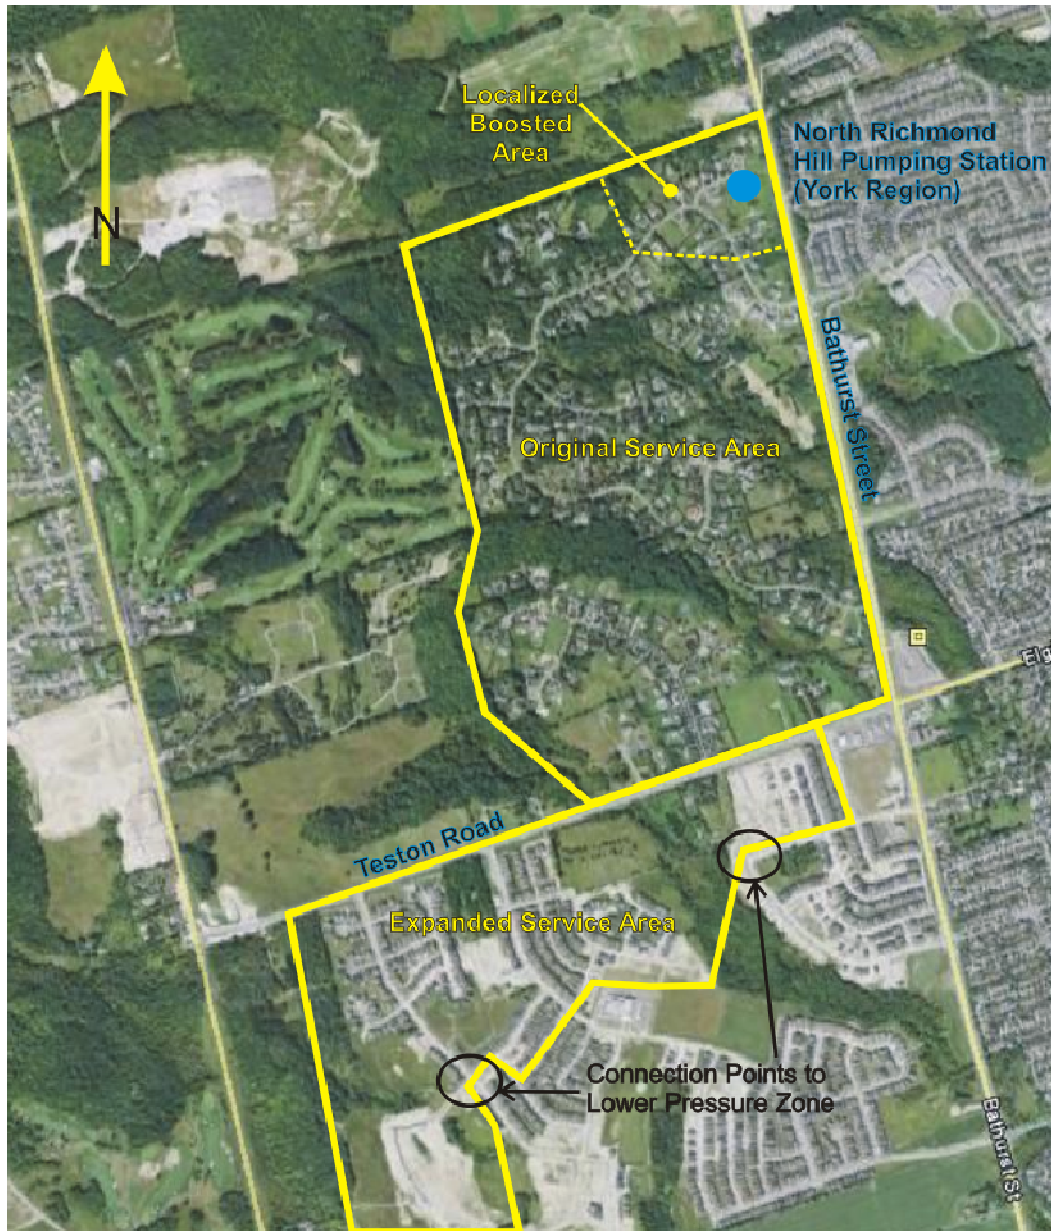
FIGURE 1. CITY OF VAUGHAN PD8 PRESSURE ZONE

The PD8 zone is supplied water by the Region of York's North Richmond Hill Pumping Station and has historically serviced a relatively mature and affluent area within the City (referred to herein as the "Original Service Area"). The northernmost area within PD8 is further isolated and serviced by a local booster pump to deal with the higher elevations in this area. (As will be noted later, this isolation negatively impacts the performance of the distribution system.) Recently, land development activities in the City have resulted in the expansion of the PD8 system (referred to herein as the "Expanded Service Area") including interconnectivity with the hydraulically lower PD7 system, although it is noted that the intent of this interconnectivity is for emergency supply purposes rather than routine operation. Figure 1 illustrates the lands in question.

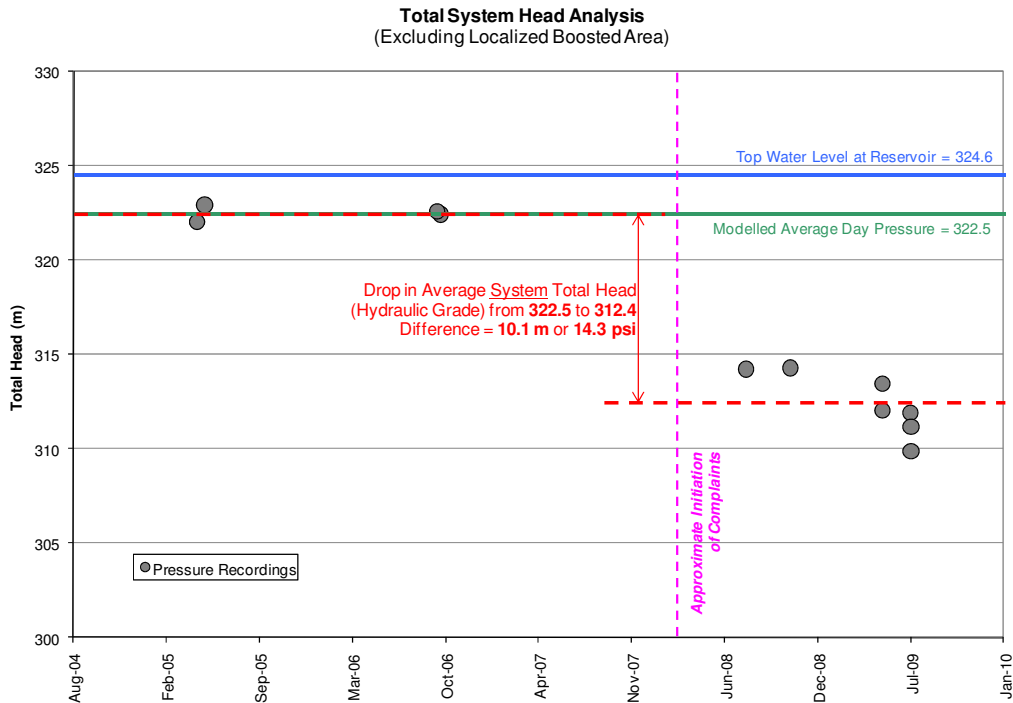
FIGURE 2. DROP IN DISTRIBUTION SYSTEM TOTAL HEAD

The engagement involved a desktop review of the system hydraulics, interviews with staff from both the City and Region responsible for water supply and distribution operations, selected field monitoring and testing. In addition, and what proved to be very useful in identifying the causes of the problem, the City had field pressure records for the system in question both before and after the onset of complaints. By looking at the system from a broader perspective, it became evident that there was a general and uniform drop in total head across the system largely as a whole which significantly narrowed the possible causes of the situation. Such a situation would either be caused by a significant lowering of the pressure at the system boundary where water was supplied such as at the pump station or a significant headloss in the distribution piping connected thereto. Figure 2 presents the data showing the drop in total head in relation to the initiation of complaints.

The data presented in Figure 2 illustrates that the total head across the distribution system was at the theoretically modeled level prior to the initiation of complaints and, thereafter, was generally observed to be on the order of 10 m or 14 psi lower. A review of pressures at the pumping station indicated that it was indeed operating as originally intended and producing pressures consistent with the recordings before the problems manifested themselves. Therefore, the only alternative explanation for this situation was that there were significant head losses in the distribution piping.

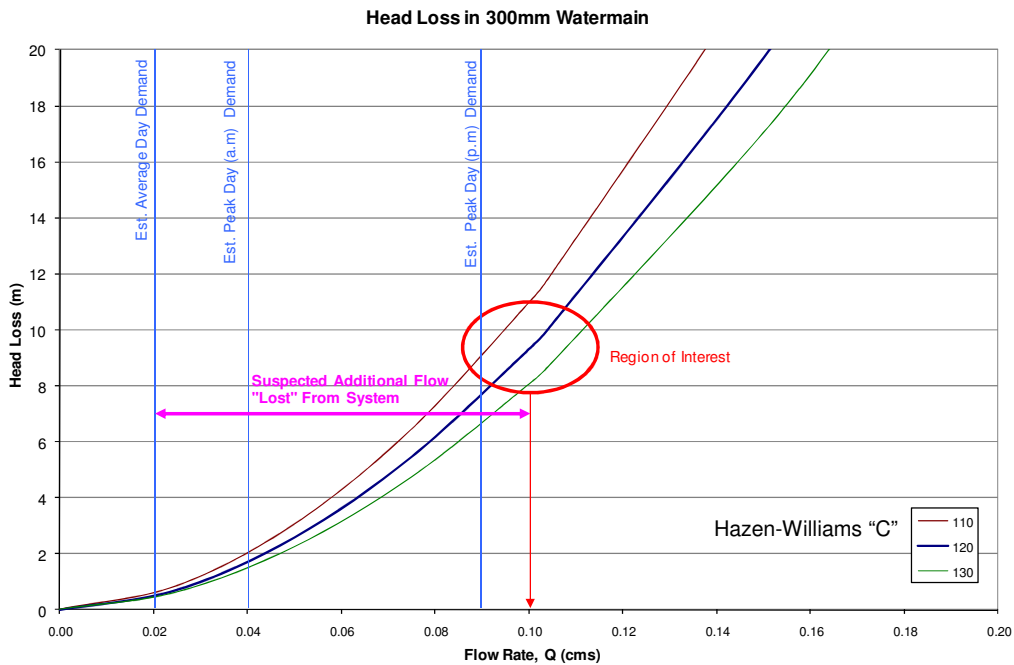
FIGURE 3. ESTIMATED HEAD LOSSES IN SINGLE FEED

A review of the system hydraulics and the field investigation revealed that the creation of the localized boosted area at the northern limit of the pressure zone effectively created a single feed from the pumping station to the remainder of the service area. Moreover, this single feed (300 mm Ø) was over 1,200 metres in length. While this feed experienced modest and largely imperceptible head losses before the initiation of complaints, it was correctly speculated that this line was particularly vulnerable, in terms of head losses, to increases in flow. A simple application of the Hazen-Williams formula for estimating head losses was developed (see Figure 3) which indicated that, for a loss of approximately 10 m of head, the required flow rate would be on the order of 100 L/s.

Given that the City does not currently have flow meters in its system, alternative methods of verifying this situation were required. This prompted the review of billing records for the bulk supply of water from the Region which, fortunately, provided direct information for the supply line in question. Immediately the results of this analysis corroborated the speculation of head losses across this single feed. Furthermore, this rate of flow was 5 to 6 times larger than what would be conservatively expected under full build-out conditions for the expansion area which was not the case.

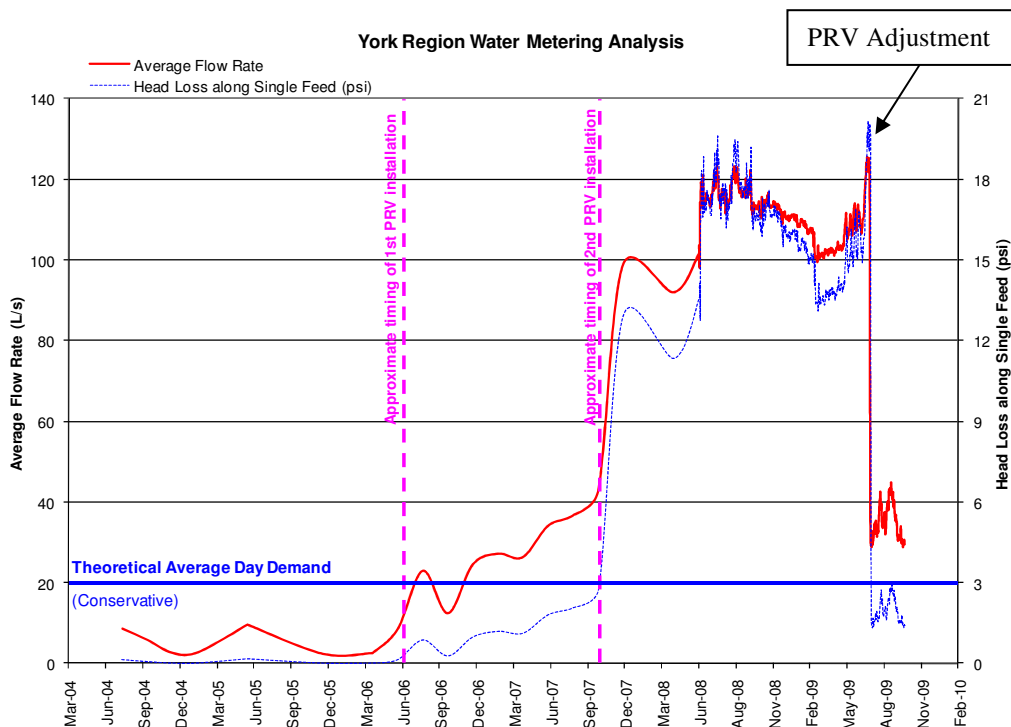
FIGURE 4. FLOW RATES AND HEADLOSSES IN SYSTEM

Figure 4 below illustrates the metered flows into the system, the theoretical headloss across the 1,200 m single feed, and the timing of events. The adjustment of the PRV on 23 July 2009 had an immediate and significant effect, improving pressures throughout the PD8 system.

Despite the improvements to the system shown in Figure 4, it also appears that the entire problem has not been fully resolved since flow rates remain higher than the conservatively estimated demand for the service area and that a further 15 to 20 L/s may continue to flow from PD8 to PD7. As at the time of writing, the City is working with the developer to identify and resolve this situation which requires additional effort.

A review of the interconnections of the PD8 and PD7 systems revealed the installation of pressure reducing valves (PRVs) which are intended to only permit the flow of water from PD8 to PD7 in the case of extremely low pressures in PD7. Accordingly, a set of field tests was conducted and which indicated that one of the PRVs was very likely allowing the flow of water between these pressure zones under regular conditions. The developer was notified and immediately mobilized its forces to work with the City and Region to investigate the PRV which was confirmed to be fully open on account of its pressure regulator not having been set.

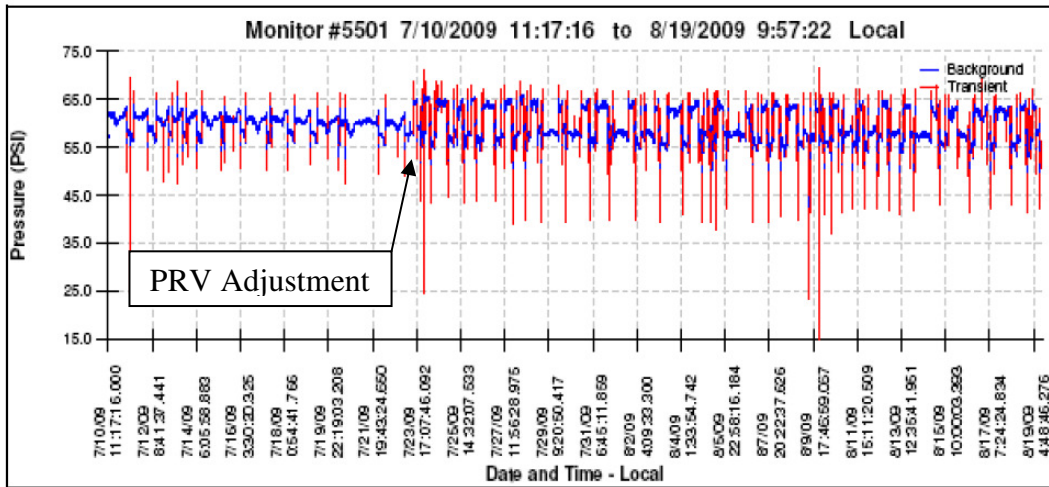
FIGURE 5. TRANSIENT PRESSURE MONITORING DATA

Prior to any work on the system and while information was being collected and reviewed by the consulting team, a TP-1 transient pressure monitor was installed by HydraTek & Associates Inc. in the discharge header of the pumping station to observe its behaviour. As noted above, prior to the adjustment to the PRV, the station performed admirably with relatively few pump switches and good transient (also referred to as “waterhammer” or “surge”) controls. Following the adjustment, however, with the significantly lower flow requirements, there was a significant increase in the frequency of pump switches and mild transient events with a wider fluctuation of discharge pressures. Figure 5 shows the transient pressure monitoring data for the period of installation.
